Appendix H

INTERIM REPORT ON EVOLUTION OF WTC FIRES, SMOKE, AND DAMAGE BASED ON IMAGE ANALYSIS

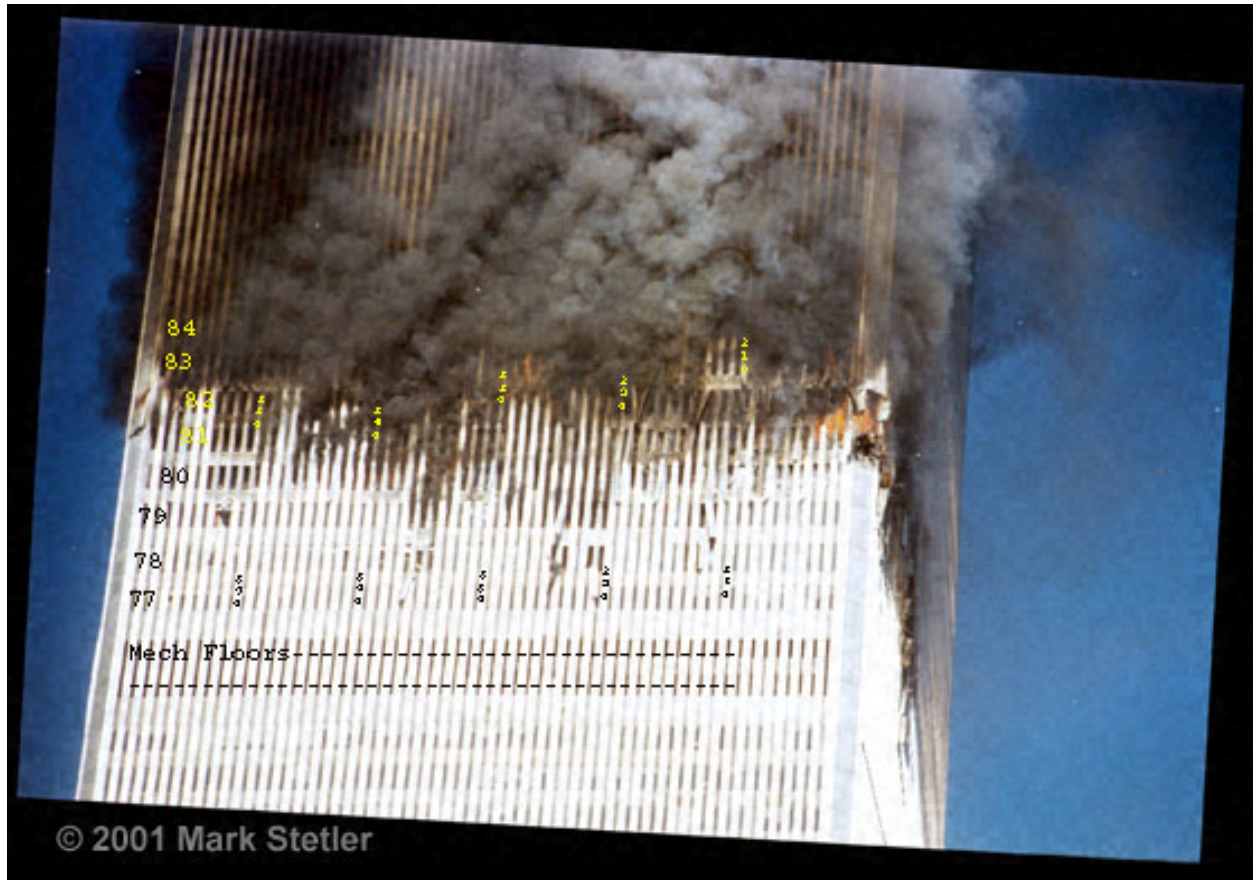
Figure H-6. Photograph taken at 9:26:20 a.m. on September 11, 2001, showing the east face of WTC 2. It has been enhanced, and lettering indicating floors and columns has been added.

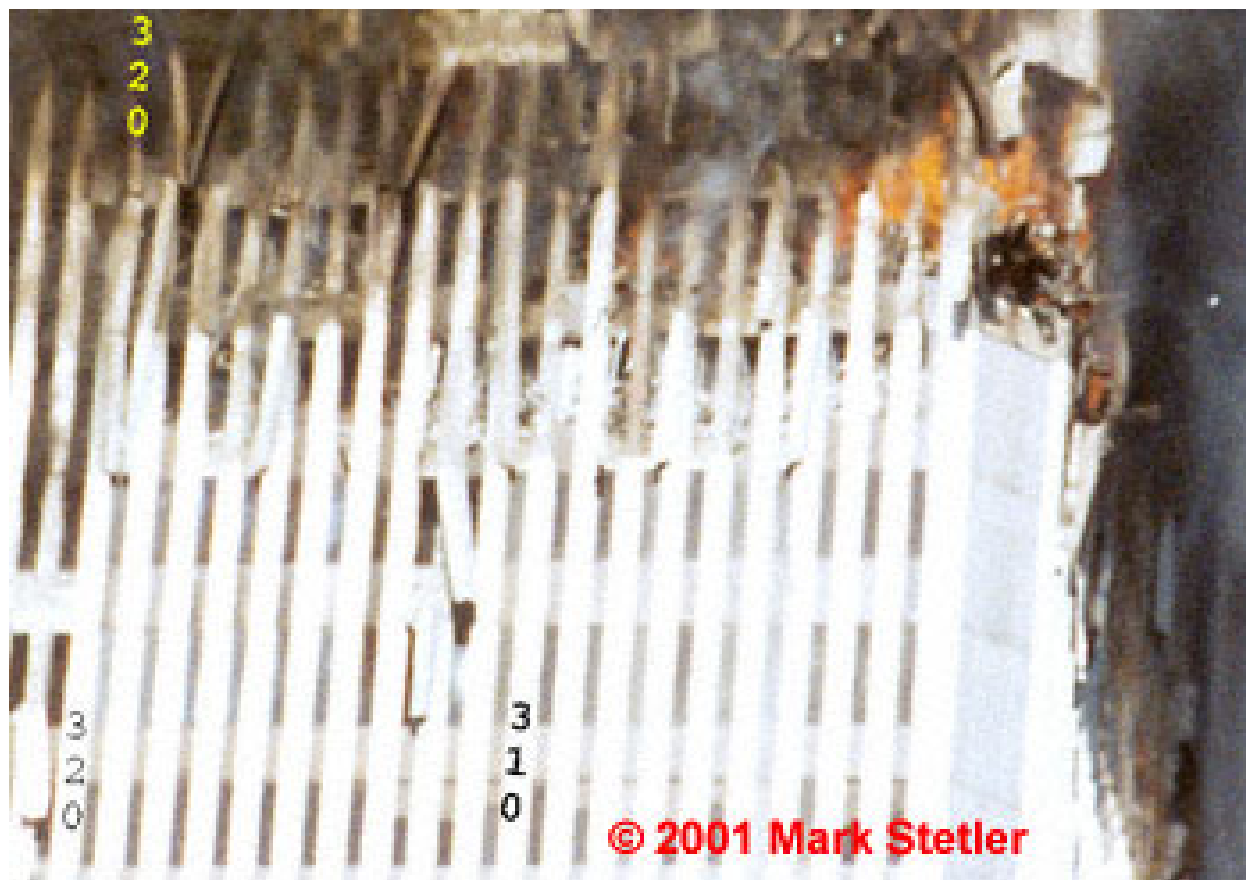
Figure H-7. This photograph is cropped from the image shown in Figure H-6. It was taken on September 11 and shows the east face of WTC 2 at the northeast corner from floor 77 to floor 82. Note the large piles of debris evident on floor 80 and floor 81.

A large number of windows are also missing on the north face of WTC 2. A substantial area of the aluminum façade was also removed during the plane strike and subsequent fireball. The missing windows on this face almost appear to be a mirror image of the south face with damage towards the center being on lower floors than on the eastern edge. This suggests that a great deal of debris passed through the entire length of the building. This hypothesis is supported by close up images that show large piles of debris on the east side of the north face on floor 80 and floor 81, and on floor 79 near the center of the face. Figure H-21 includes a photograph showing these debris piles. Recall that piles of debris were also evident on floor 80 and floor 81 on the north side of the east face (see Fig. H-7).

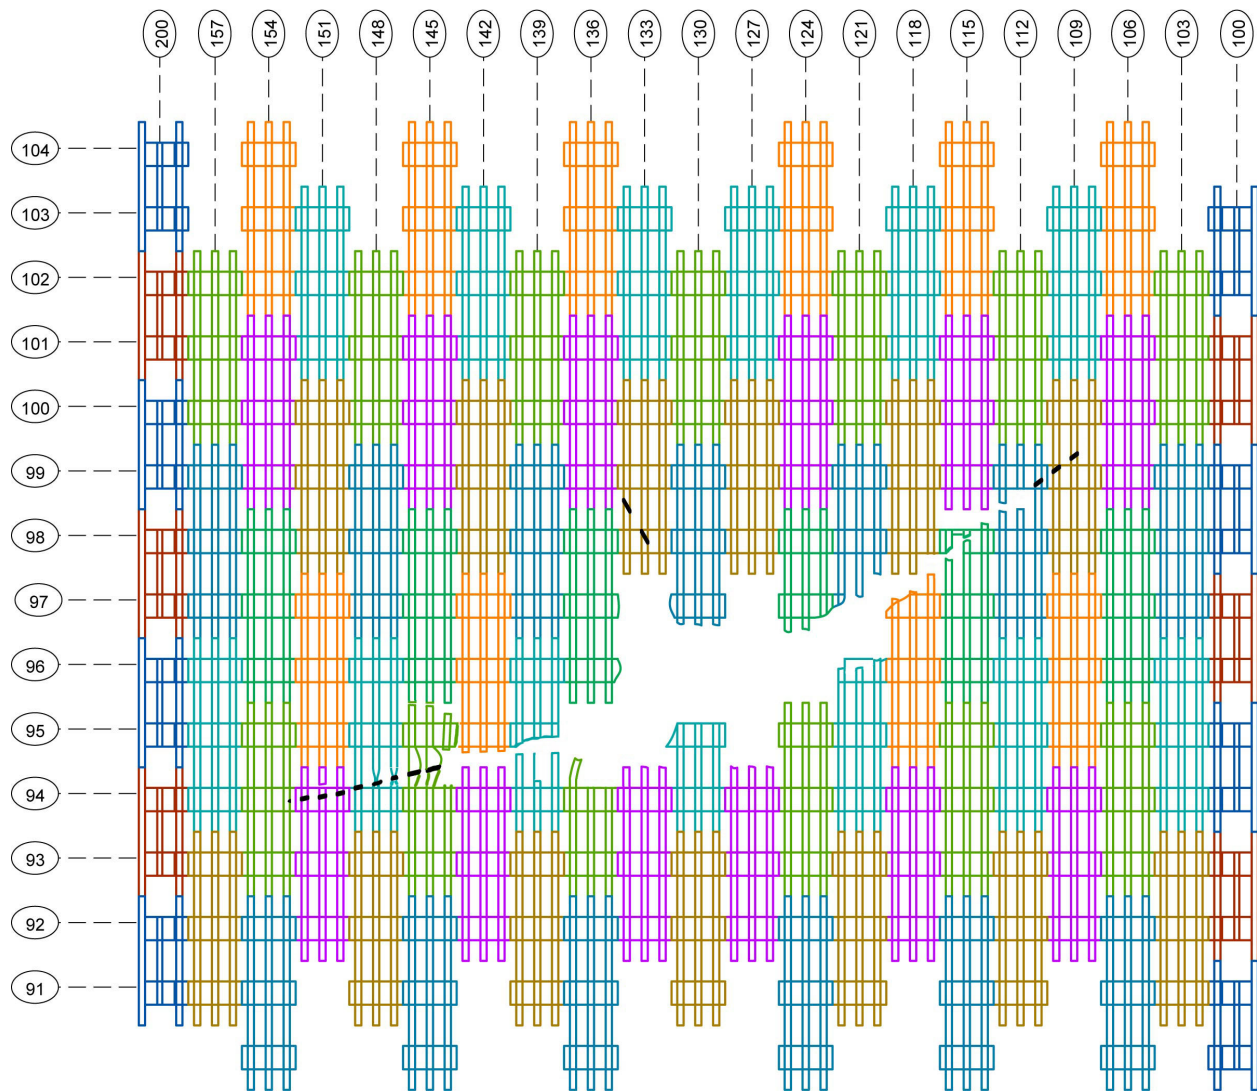
A detailed drawing of the damage to the steel façade of WTC 1 was included in the FEMA *World Trade Center Building Performance Study* (McAllister 2002). A careful inspection using photographs and videos in the database confirmed the accuracy of this analysis. Figure H–12 shows a drawing that represents this damage. It is similar to that included in the FEMA report, but it incorporates several minor changes that better reflect the geometry of the north face of WTC 1 in the vicinity of the plane strike.

It was observed that the wing tips and the end of the vertical stabilizer at the plane's tail section damaged the aluminum column covers on the steel façade without cutting through the steel below or completely removing the covers. By inspection it was possible to map out locations on columns where the wingtips and the vertical stabilizer struck the tower. These locations were then transferred to the representation of the damaged steel façade shown in Fig. H–12 and are represented by dashed lines, with wings to the right and left and the vertical stabilizer in the center. The good agreement between the damage pattern and the wing tip locations is evident. It is reported in the FEMA report (McAllister 2002) and widely in the media that American Airlines Flight 11 struck floors 94 to 98 of WTC 1. The dotted horizontal lines on the left side of Fig. H–12 indicate the locations of concrete floors. It can be seen that while the tip of the left wing of the aircraft struck very close to the base of floor 94, the wing end marked column 153 at the very top of floor 93. It is evident from the figure that the right wing actually struck well up on floor 99 on column 109. The impacted floors therefore range from floor 93 to floor 99.

Figure H-12. A drawing of the damage to the steel façade of WTC 1. The dark dotted lines show locations where the airplane wings and vertical stabilizer marked the aluminum cladding on columns.

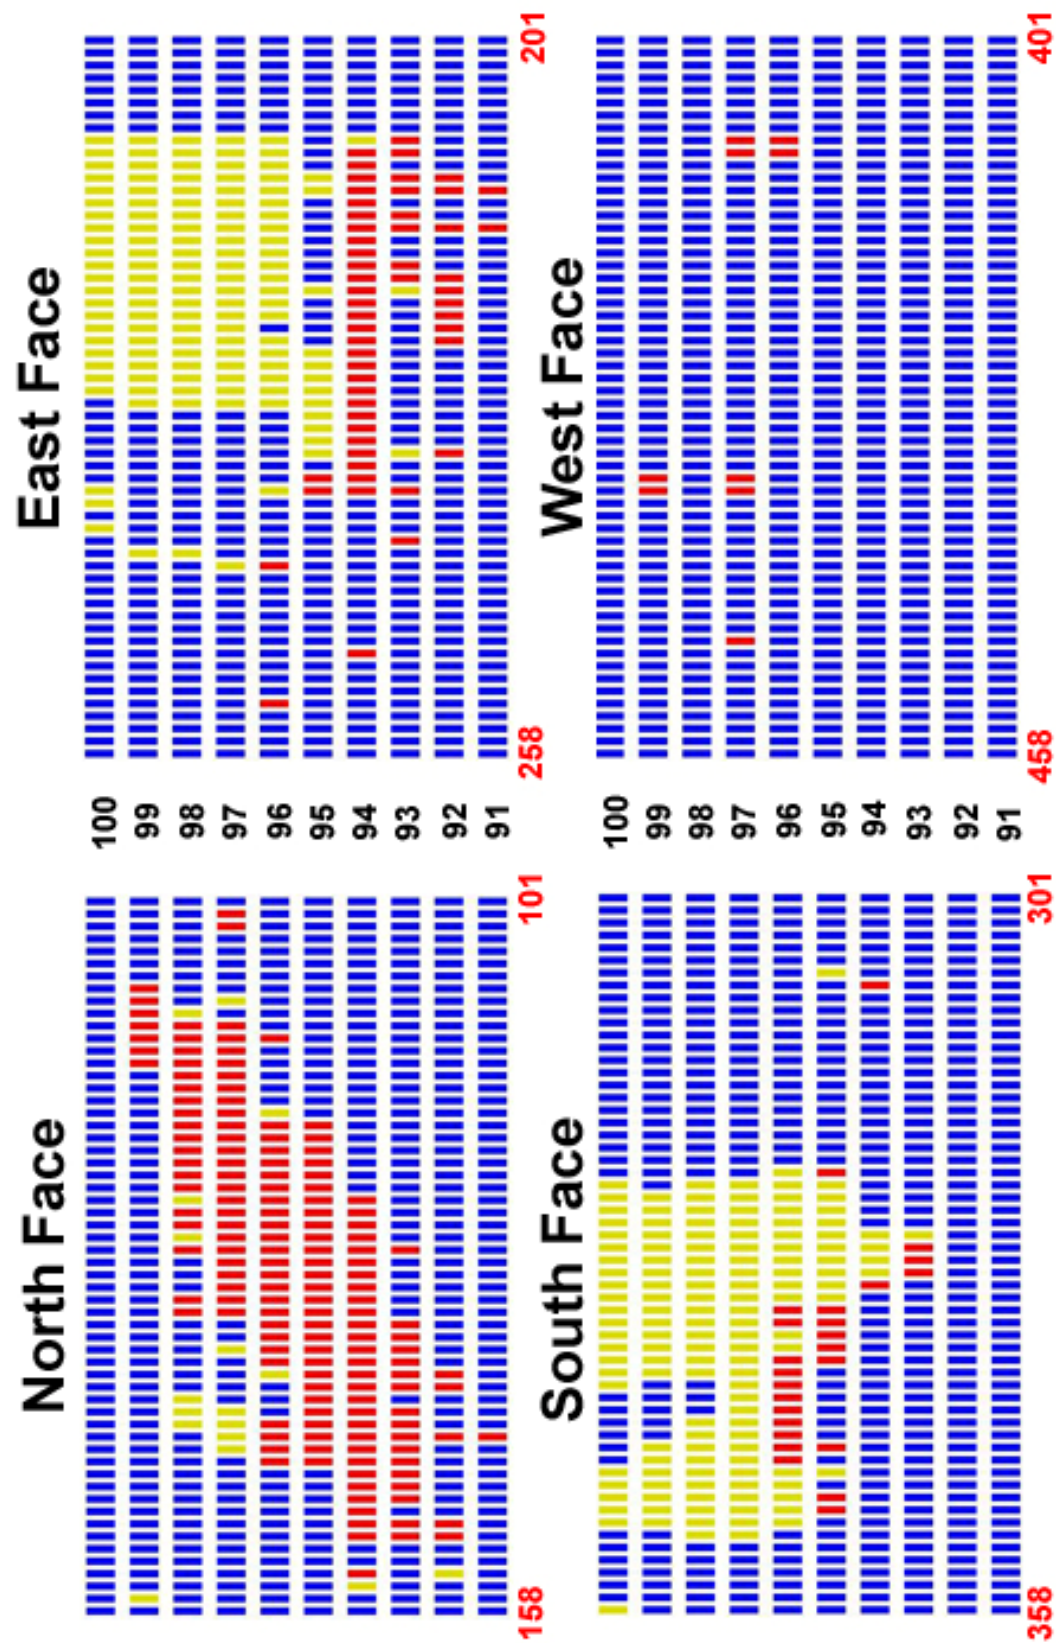
Additional insights into the initial damage inflicted on the towers by the plane strikes can be obtained by considering locations where fireballs are observed immediately following the plane strikes as well as locations where windows are missing. Videos and photographs recorded during and immediately following the plane strike on WTC 1 show that significant fireballs formed at the plane strike location on the north face, as well as near the center of the east face and on the western side of the south face. Figure H–13 compares window damage for the four sides of WTC 1 immediately after the plane strike. The floors shown extend from 91 to 100. The missing windows on the north face are consistent with the plane strike location and strike angle. The plane struck very close to the center of the face. Interestingly, the damage on the east and west faces appears to be asymmetric with a much higher number of windows missing on the east face than on the west. This observation is consistent with the formation of a fireball on the east side of the tower and not on the west side. Areas obscured by smoke are also much larger on

the east side suggesting that more fire is present on this face as well. An asymmetry is also apparent on the south face where only a single window is missing on the east side while numerous windows are missing and significant smoke is present on the west side. Taken together, these observations suggest that debris and fuel from the airplane as well as any building materials and contents tended to pass straight across the building on the west side, while material on the east side was somehow reflected and more heavily damaged the east face.

Figure H-13. The condition of windows is shown for the four faces of WTC 1 around 8:47 a.m. shortly after it was struck by American Airlines Flight 11. The colors represent ■ - window open, ■ - window in place, and ■ - not visible.

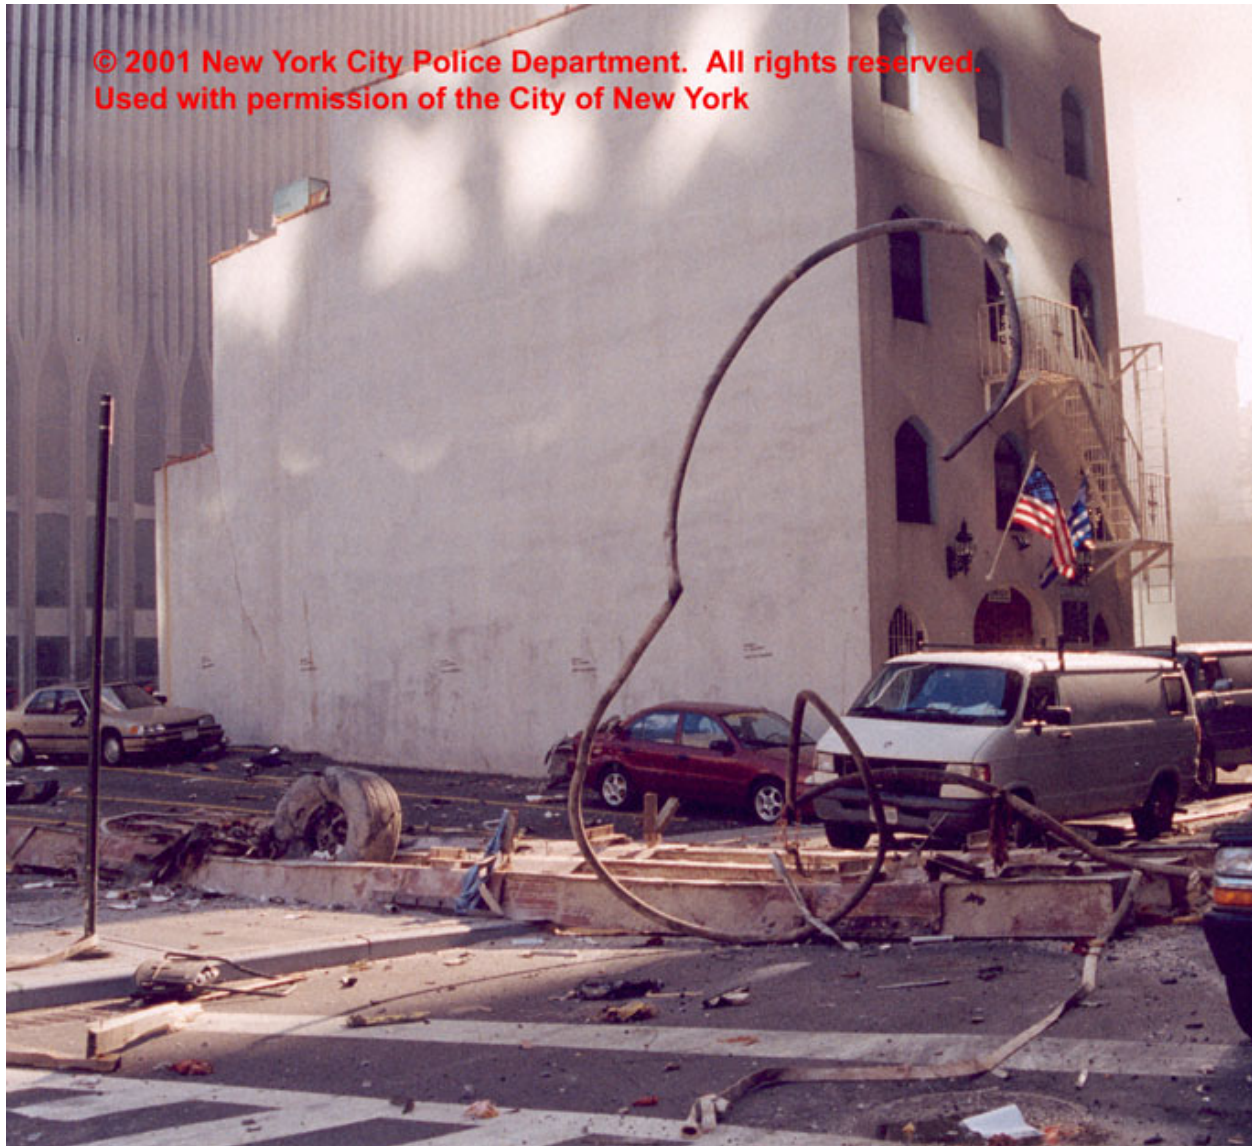
A photograph supplied by the NYPD provided additional details with regard to the initial damage suffered by WTC 1. Figure H-14 shows a full three-story three-column-wide steel panel section lying on the corner of Cedar Street near its intersection with West Street. This location is to the south of and roughly 210 m from the south face of WTC 1. The photograph was taken prior to the collapse of either tower. Closer inspection shows that there is an aircraft wheel embedded in one of the windows. The most likely source location for this panel section has been identified as being near the center of the south face of WTC 1 (i.e., columns 329 to 331) and extending from the middle of floor 93 to the middle of floor 96. This conclusion remains tentative since, as indicated in Fig. H-13, the area is obscured by smoke in all of the close-up photographs of the area in NIST's possession. If the location is identified correctly, the wheel is stuck in window 95-329.

Figure H-14. Photograph showing a full panel section lying in Cedar Street near its intersection with West Street. An aircraft wheel can be seen imbedded in one of the windows. The building behind the panel is Saint Nicholas Greek Orthodox Church and the lower section of WTC 2 can be seen across Liberty Street.

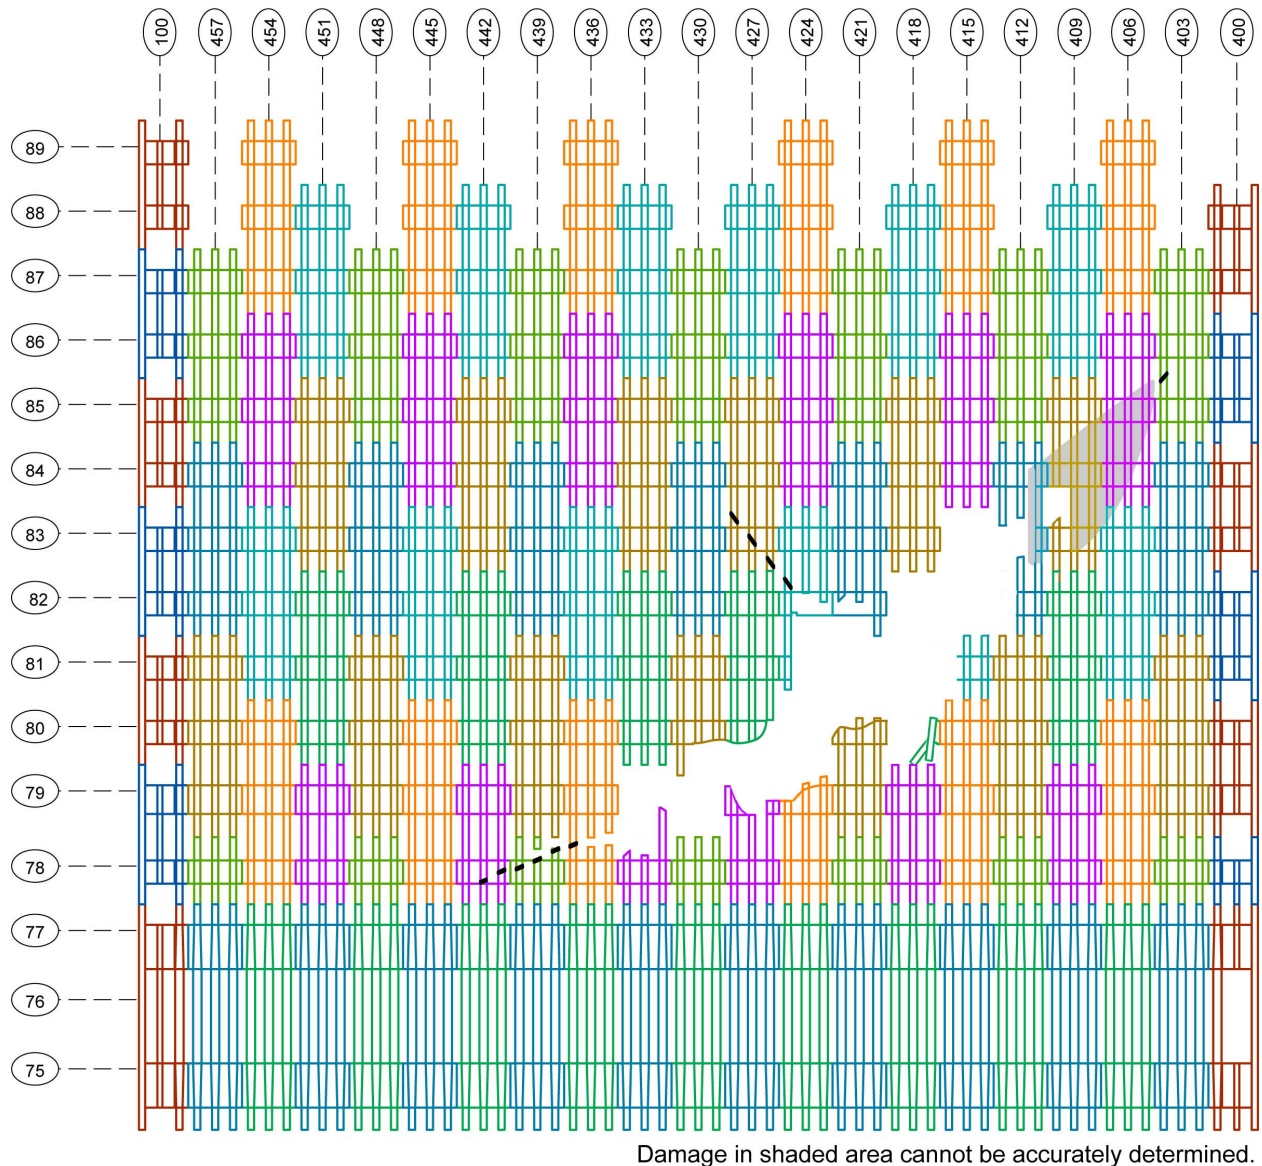
The results of an analysis of the damage to the steel façade of the south face of WTC 2 are provided in Fig. H-19. Much of the steel damage pattern is revealed, but it should be noted, as indicated, that a portion of this face on the east side of the plane strike location was constantly obscured by smoke, and the detailed pattern could not be discerned. The FEMA report (McAllister 2002) also includes a figure describing the damage to the steel façade inflicted by United Airlines Flight 175. The pattern in Fig. H-19 differs somewhat from that provided in this earlier study. Some inconsistencies in façade dimensions have also been corrected in the current version.

Figure H-19. A drawing of the damage to the steel facade of WTC 2. The dark dotted lines show locations where the airplane wings and tail marked the aluminum cladding on the columns. The area shaded in gray was hidden by smoke and could not be observed.

As was true for WTC 1, in areas of the façade struck by the wing tips and the upper portion of the vertical stabilizer the aluminum covering was marked, but the aluminum covers were not removed and the steel was not cut through. Measurements for the location of the left wing tip were mapped out as shown in Fig. H-19. As already noted, the area at the end of the right wing was obscured by heavy smoke. However, there were brief periods when the location of the last column struck by the wing tip could be observed. This location is indicated on column 404 of floor 95 in Fig. H-19. The center of the plane strike is clearly located towards the east side of the face. The left wing mark extends to the bottom of the spandrel located below floor 78. The actual location of the concrete floor is well above this point, which means the lowest point struck lies on floor 77. Thus, the plane strike location on WTC 2 extends from floor 77 to floor 85. This can be contrasted to the FEMA study (McAllister 2002) and most media sources that report the floors struck extended from floor 78 to floor 84.

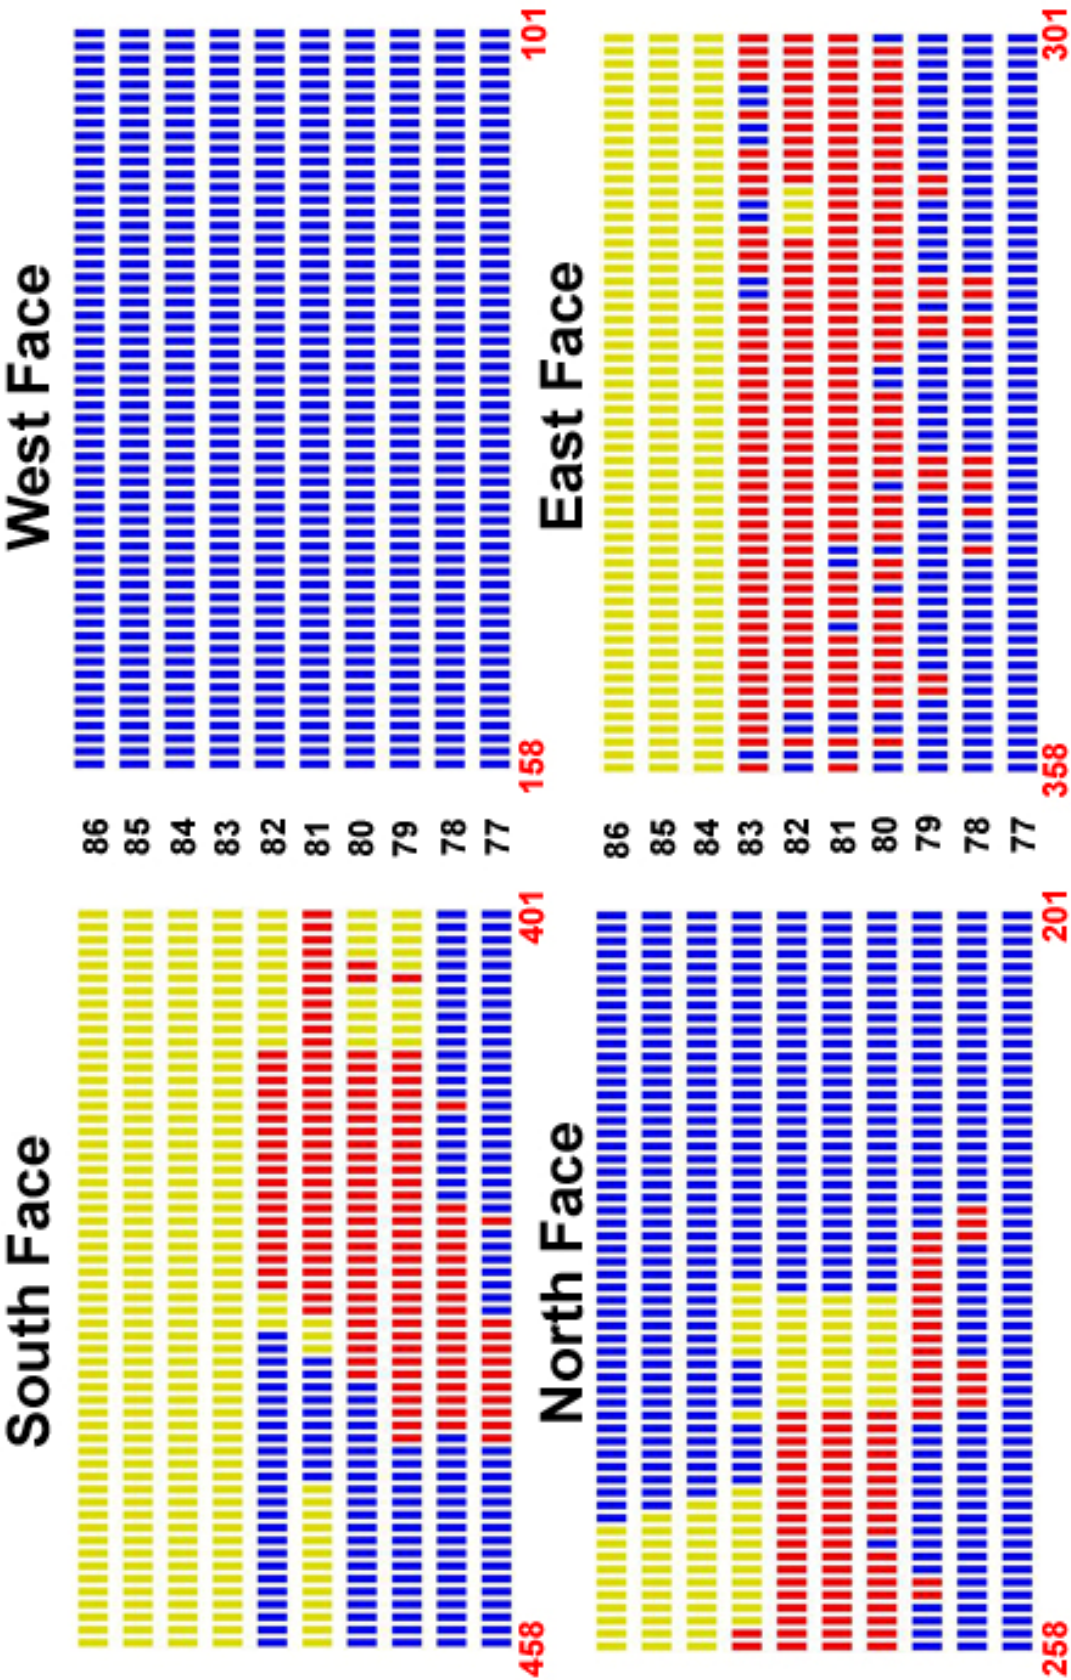
Intense fireballs were observed on the south, east, and north faces of WTC 2 following the plane strike. Figure H-20 compares missing windows on floor 77 to floor 86 for the four faces of WTC 2 shortly after the plane struck at 9:02:59 a.m.

The distribution of missing windows on the south face traces roughly the outline of the plane strike, with missing windows increasing in height from left to right. Recall that a portion of the east side of this face could not be observed due to smoke obscuration. The analysis indicates that a very large number of windows were removed on the east face by the collision and subsequent fireball. This is particularly true on floor 80 to floor 82. Photographs and videos show that extensive areas of the aluminum covering the façade and holding windows were removed, exposing the steel panels, as a result of the plane strike and fireballs. This damage is much more extensive than observed on the east face of WTC 1, consistent with the plane strike occurring closer to this face. In contrast to the extensive damage on the east face of the tower, no missing windows were found on the west face.

Figure H-20. The condition of windows is shown for the four faces of WTC 2 around 9:03 a.m. shortly after it was struck by United Airlines Flight 175. The colors represent ■ - window open, ■ - window in place, and ■ - not visible.

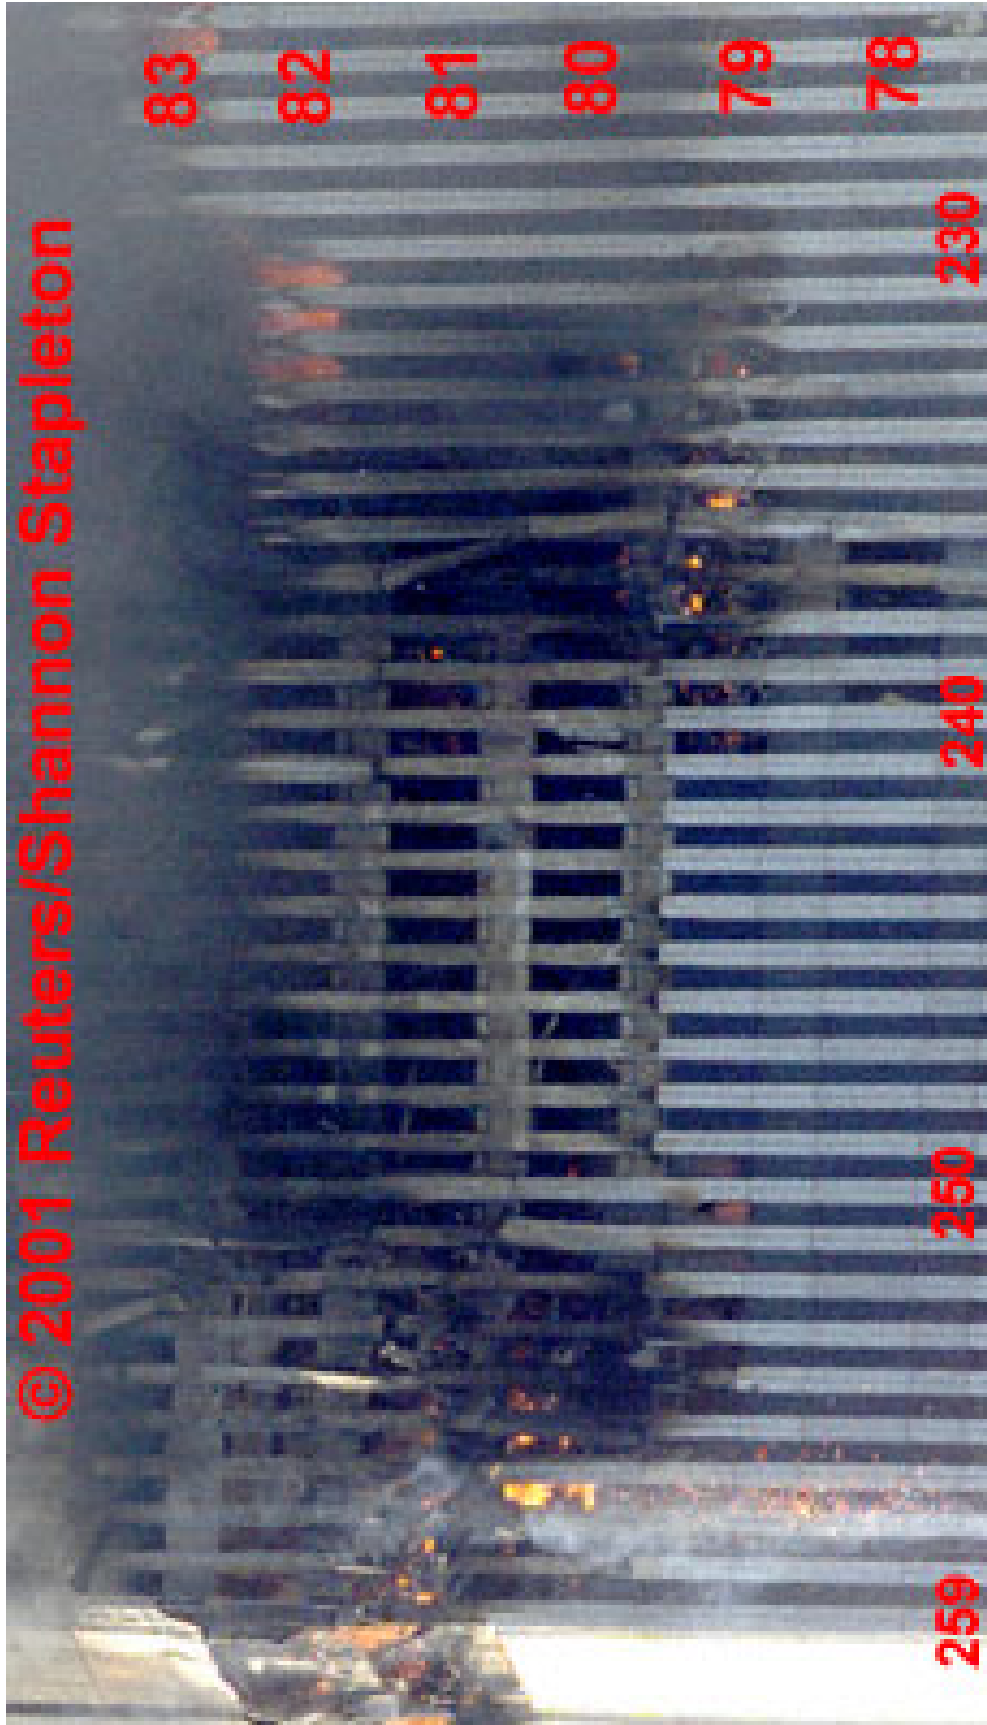
Figure H-21. An enhanced photograph of the north face of WTC 2 taken at 9:58 a.m. shows the east side of the north face. Piles of debris are evident on floor 80 and floor 81 on the northeast corner and on floor 79 to the right of column 230. The “cold” area extends over floor 80 to floor 82 from roughly column 229 to 240. There is a break in column 253 on floor 81, and the adjacent column, 254, is bent. Floors 80, 81, and 82 appear to be partially collapsed. It appears as if the collapsed floor 83 in the northeast corner has broken into sections.

Very similar objects, albeit of shorter length, are seen hanging in windows in images taken from the north. These objects are apparent in Fig. H-21 hanging below floors 81, 82, and 83. As seen through windows on floor 82 (corresponding to the floor 83), the floor appears to have split into at least two sections.

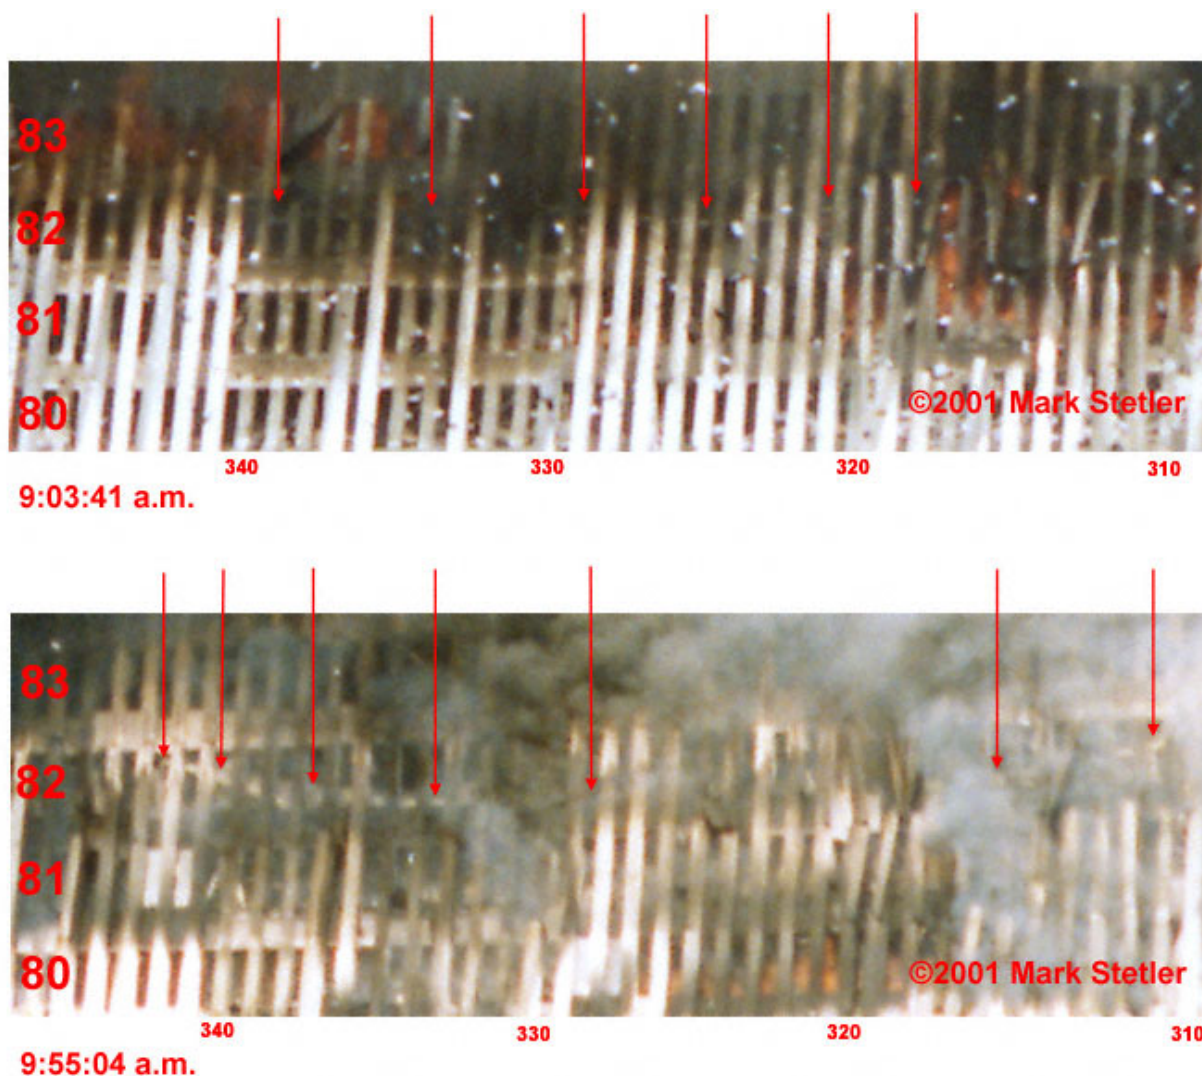
In the *May 2003 Investigation Progress Report* (NIST 2003), a photograph was shown in which there appeared to be a floor draped across a number of windows extending roughly from 310 to 342 across the east face of floor 82 of WTC 2. Figure H-22 compares an image taken shortly after the plane strike at 9:03 a.m. and one taken at 9:55 a.m. shortly before the tower collapsed. At the earlier time, the hanging object is already present, but is seen through the windows draped much higher on the floor 82. An interpretation consistent with these observations is that floor 83 along the east side of WTC 2 was partially collapsed over a significant fraction of its length by the passage of the plane through the building. At the later time the floor has sagged further. By reviewing a number of photographs and videos, it has been determined that the change in floor position occurred between 9:34 a.m. and 9:38 a.m.

Figure H-22. Images of the east face of WTC 2 taken shortly after the plane struck and shortly before the tower collapse are shown. An object that is most likely a floor can be seen through windows on floor 82 as indicated by the arrows. The object has dropped lower between the times the two photographs were taken.
